RE: Site Inspection, Star Stone Quarries, Inc., Santa Barbara Quarry, S/013/006, Duchesne County, Utah

Date and Time of Inspection: April 4, 2002, about 3:00 p.m.
Conditions: Mostly clear, 70's
Participants: Lynn Kunzler and Paul Baker, DOGM

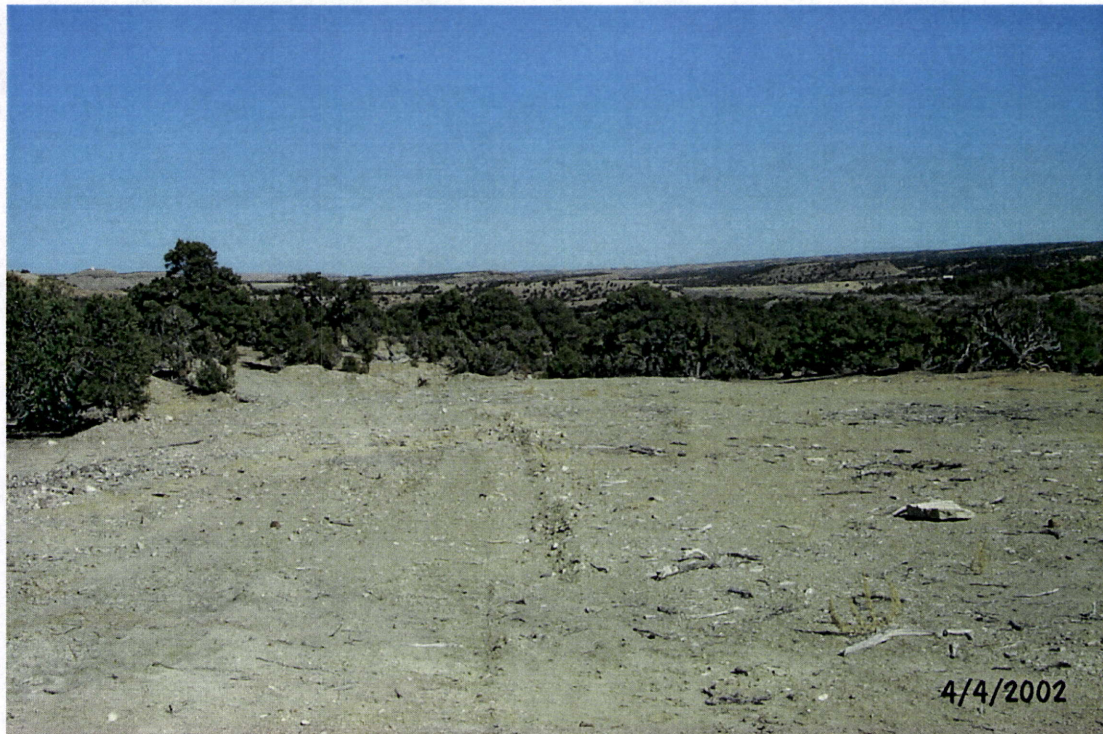
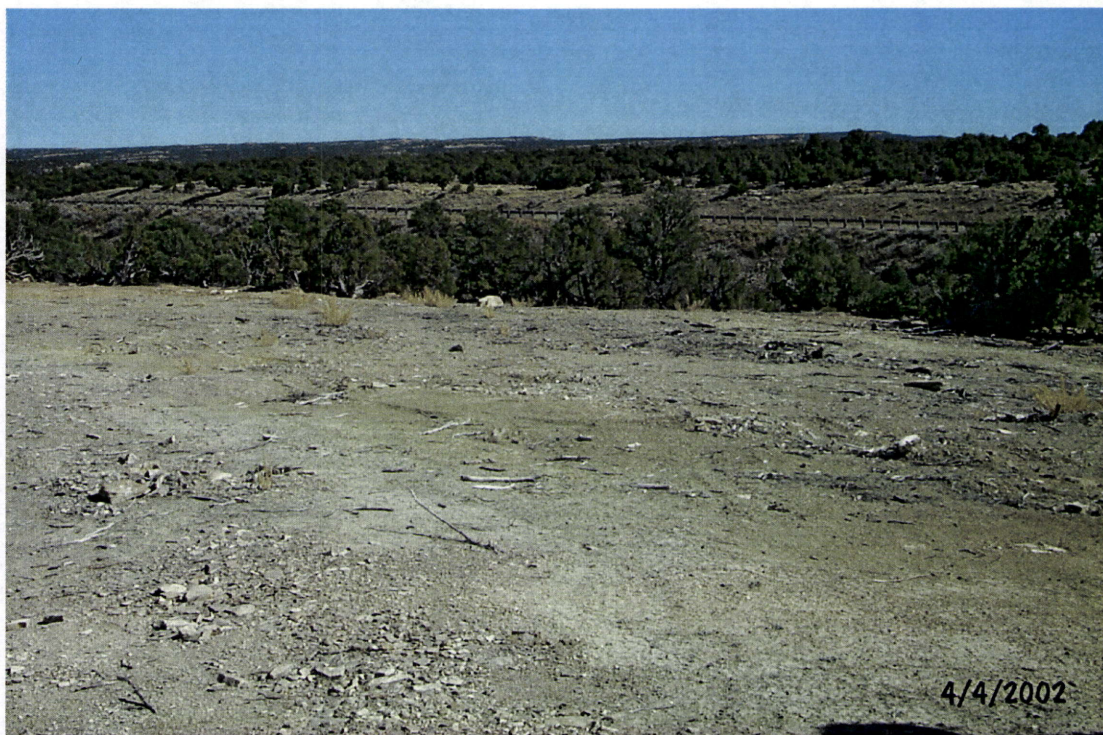
Page 1
S/013/006
Photographs of Santa Barbara Quarry
April 4, 2002

The disturbed area is about one acre, and it has been graded smooth. There are a few Halogeton plants growing in the area but little else. The vegetation community in the surrounding area is pinyon/juniper. There were no signs of rilling or gullyng.

Because there was so little vegetation, it did not appear the site was seeded when it was reclaimed. The area needs to be seeded in the fall. Minimally, it should be seeded and raked, but ideally, the operator would rip then seed the area. Since the surrounding vegetation is pinyon/juniper, I consider the probability of revegetation success at this site to be high. The site does not meet reclamation standards, and the operator needs to pay the permit fee.
